No flush C250CS

No flush C250 CWE

No flush C250S

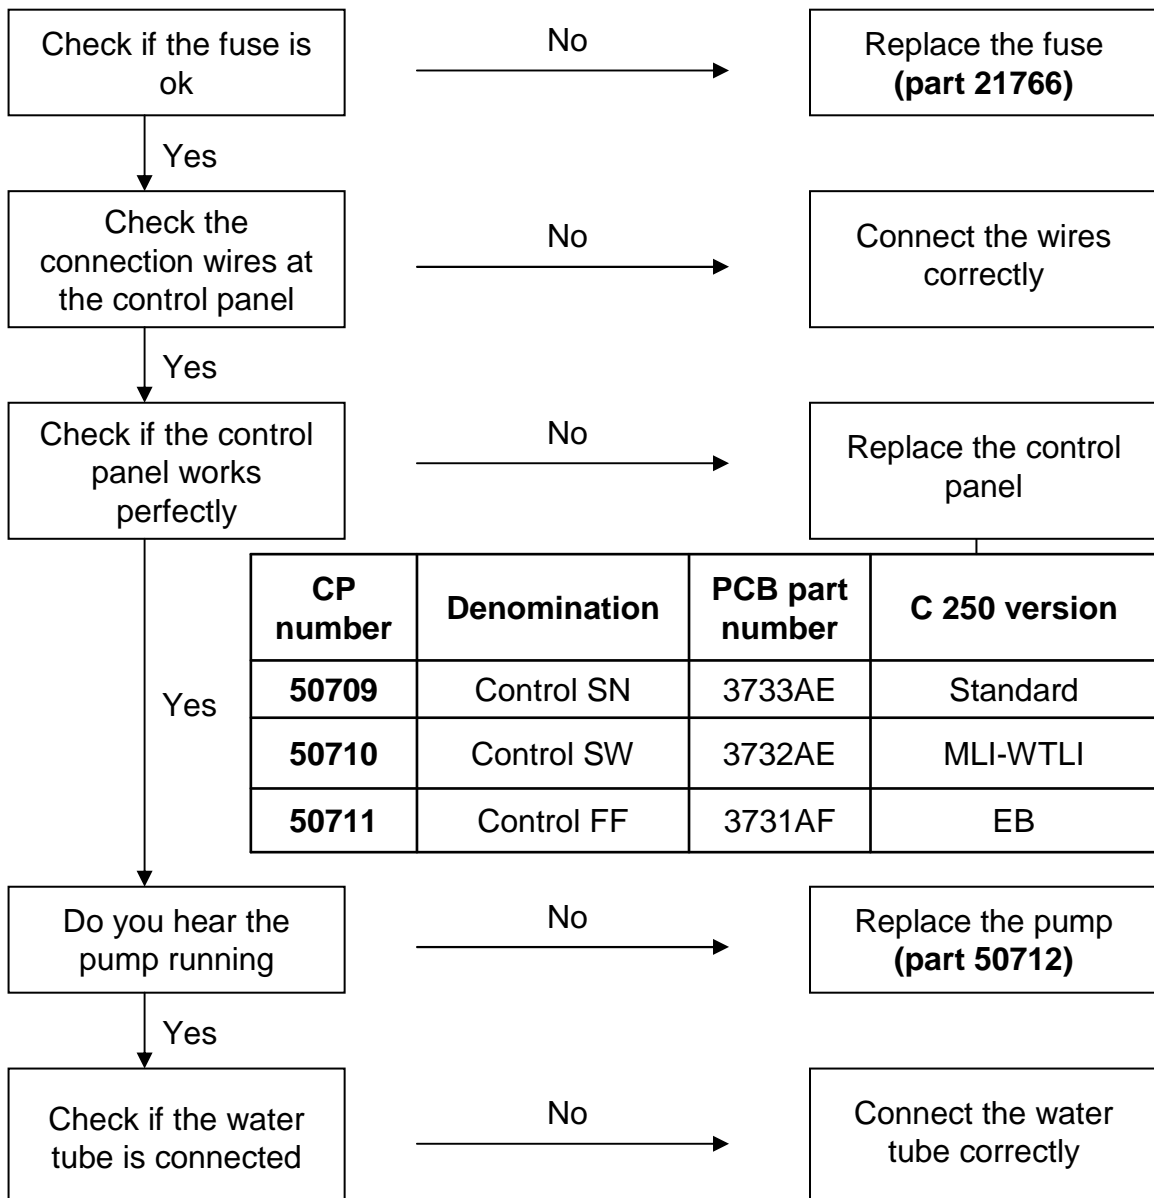
Before starting, check if the toilet is well connected
see the 12V connection scheme

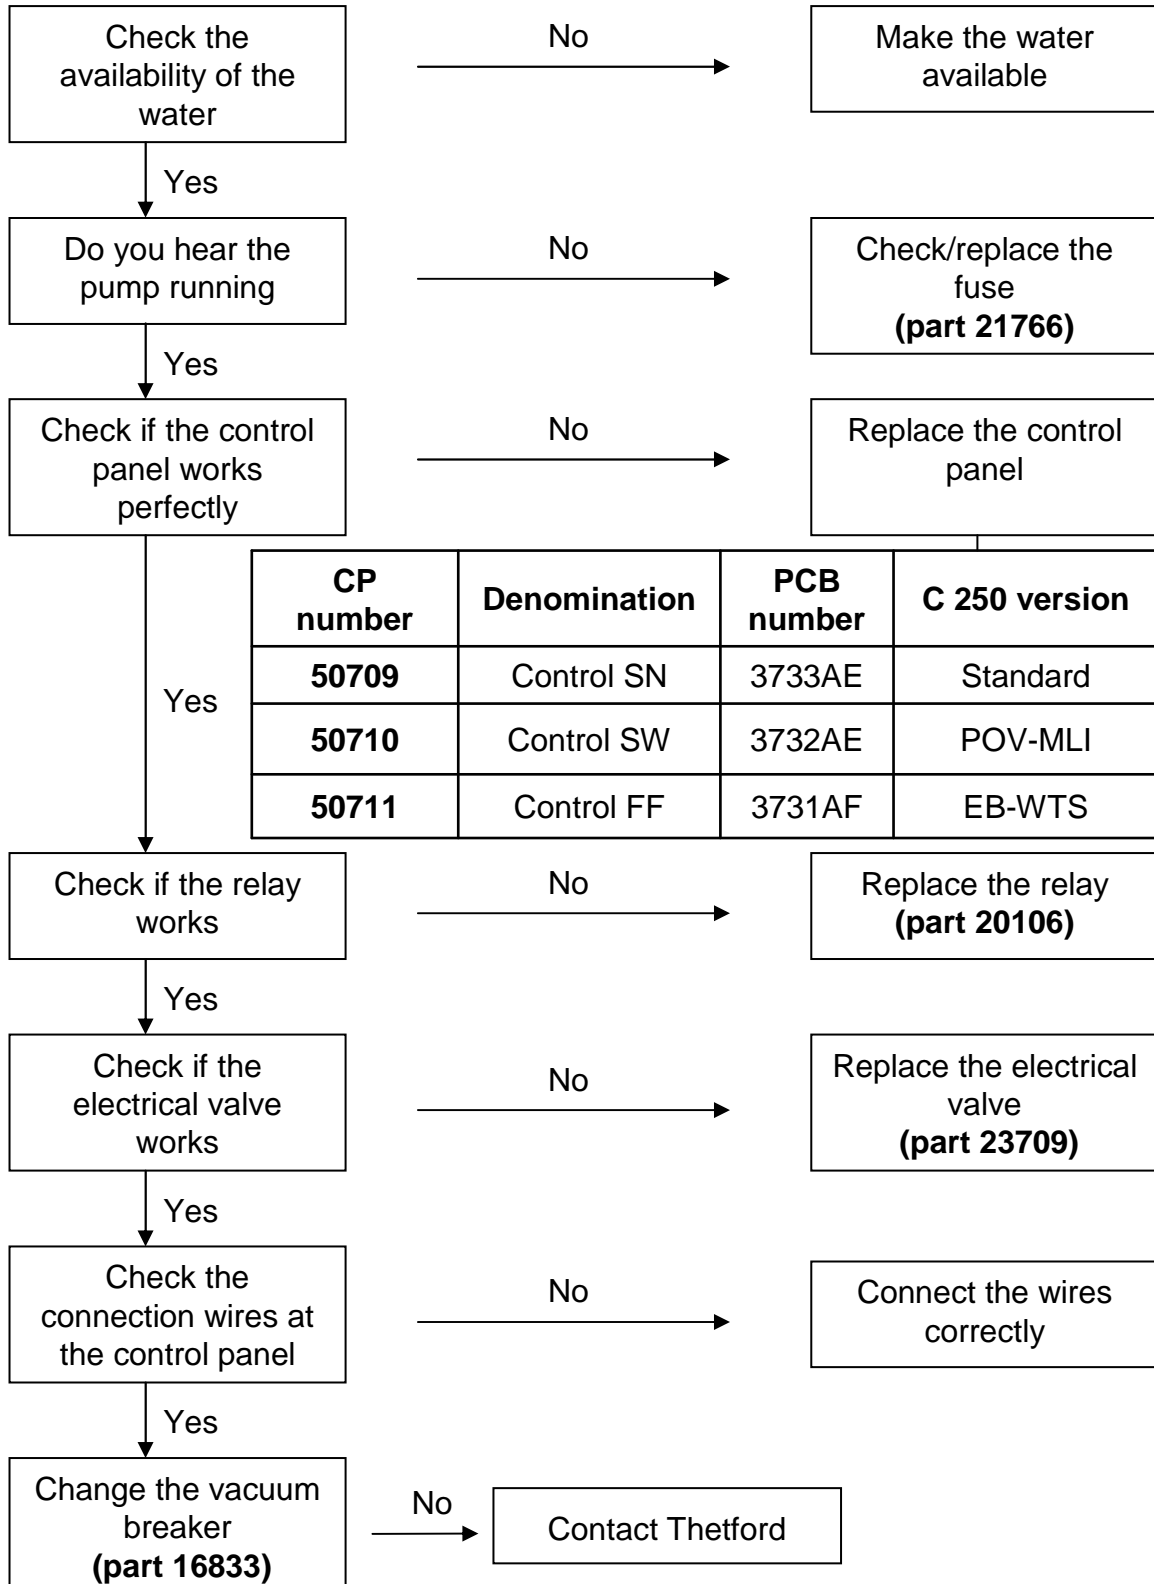
Ensure that the vehicle water pump functions
